Appendix A: Site Reconnaissance Photographs (November 22, and December 2, 2013)

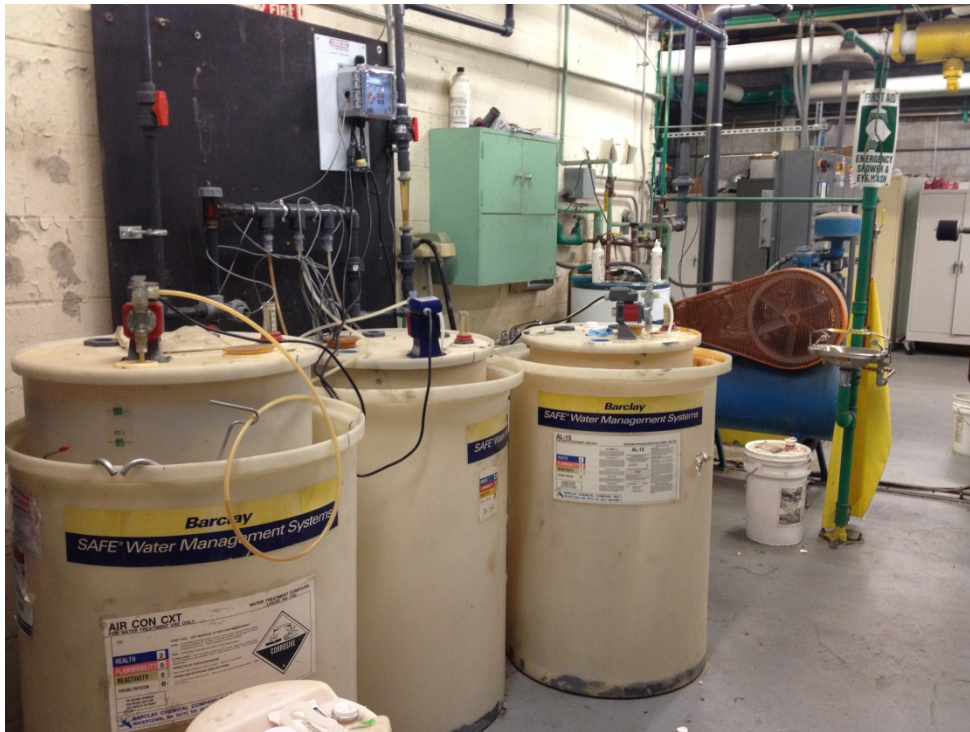
Interior 1 - Chemical Drums inside Building 5

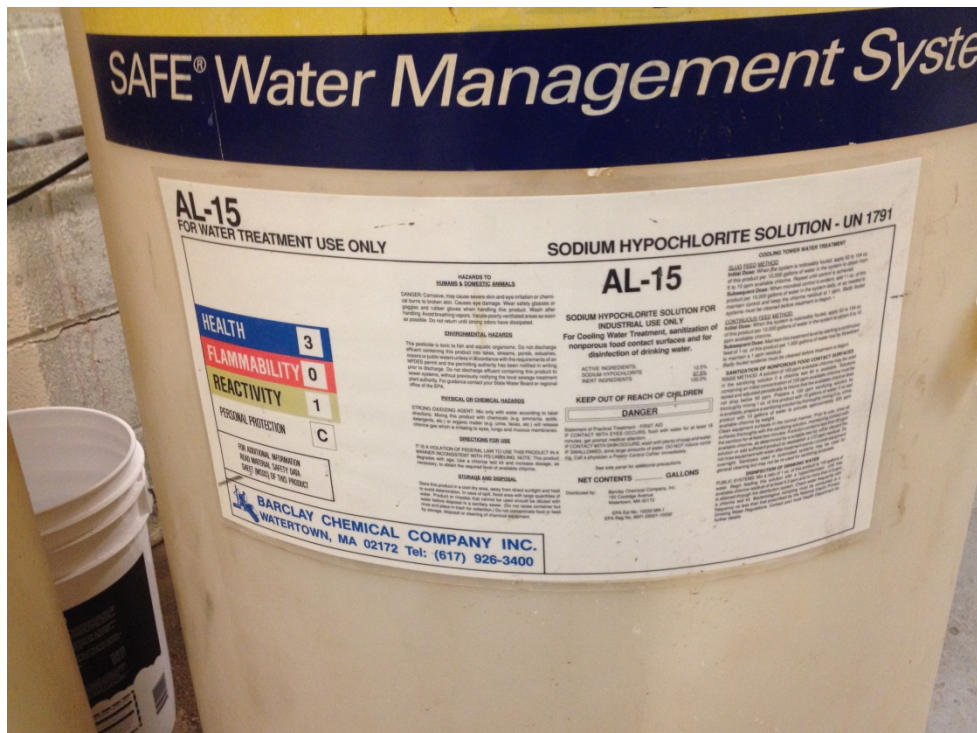
Interior 2 –Sodium Hypochlorite Solution inside Building 5

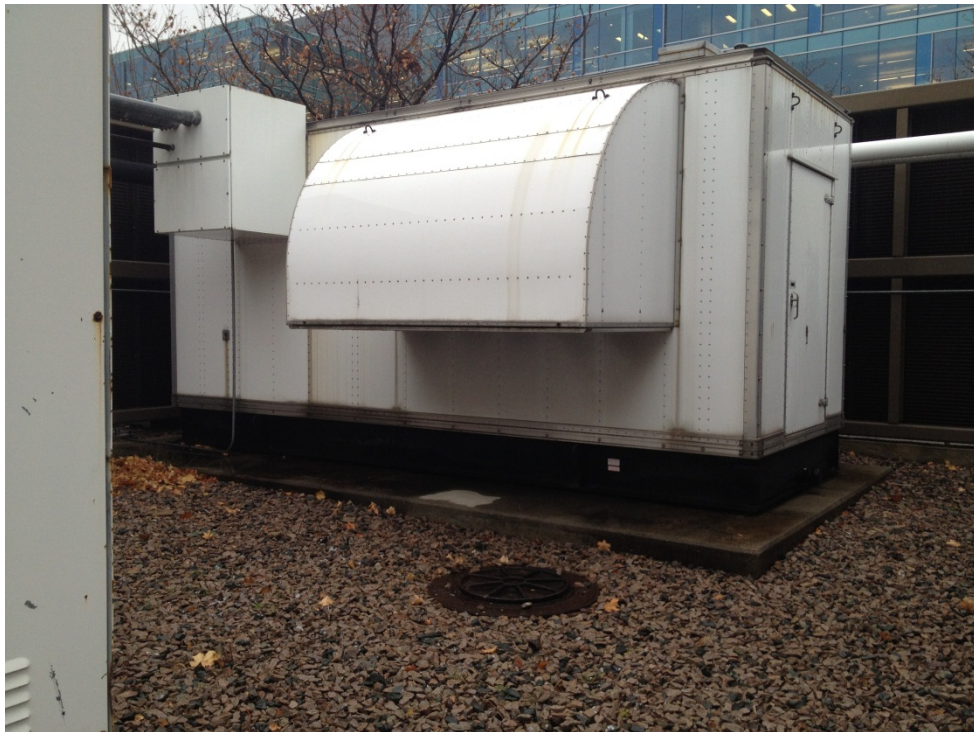
Exterior 1 – Engine/Generator Trailer with AST below outside of Building 5

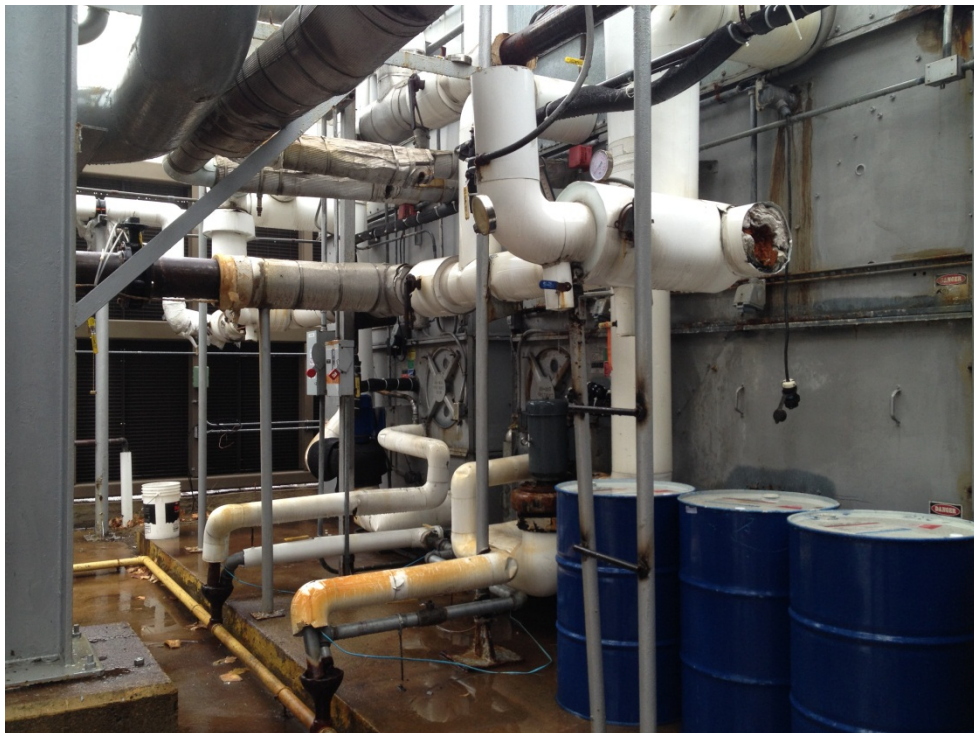
Exterior 2 - Drums of Propylene glycol

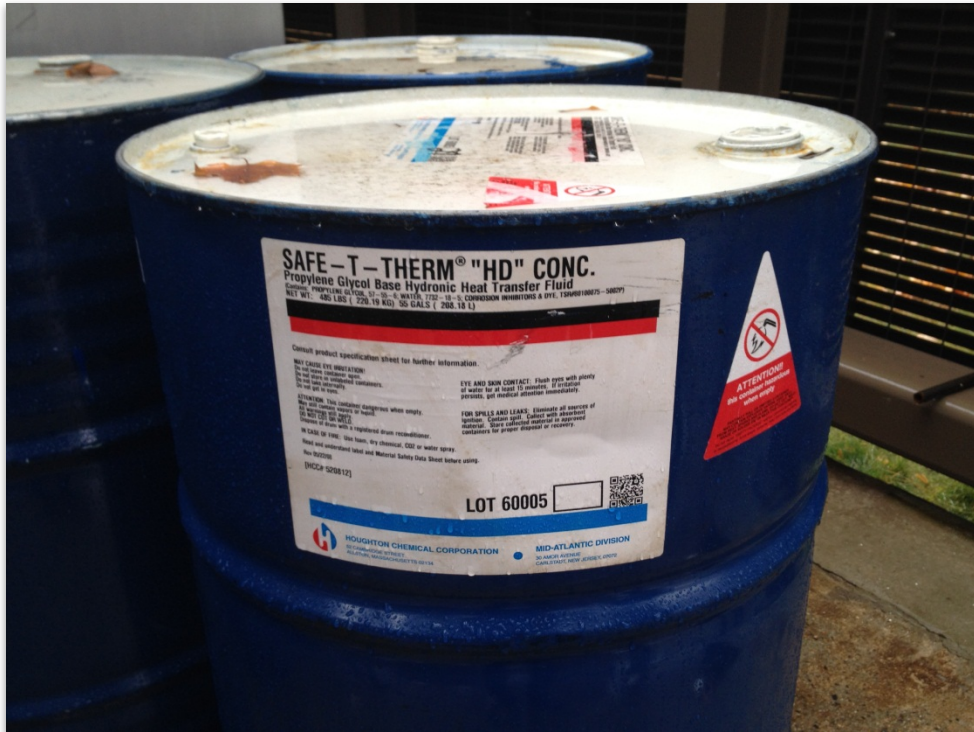
Exterior 3 – Close up of Propylene Glycol Drum

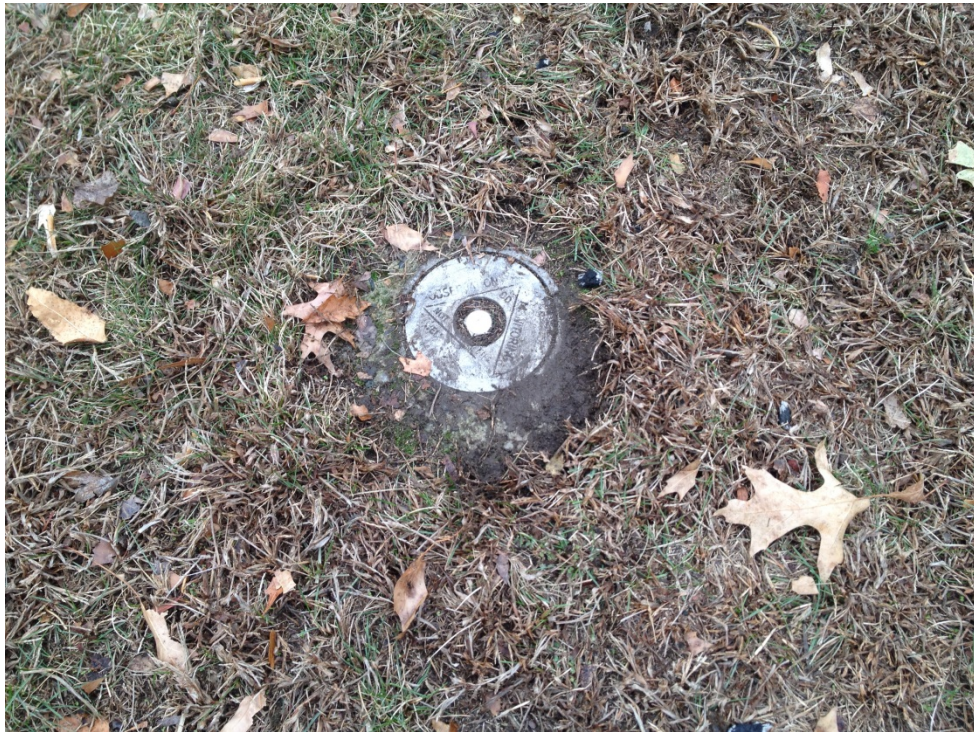
Exterior 4 – Close-up monitoring well east of Playground

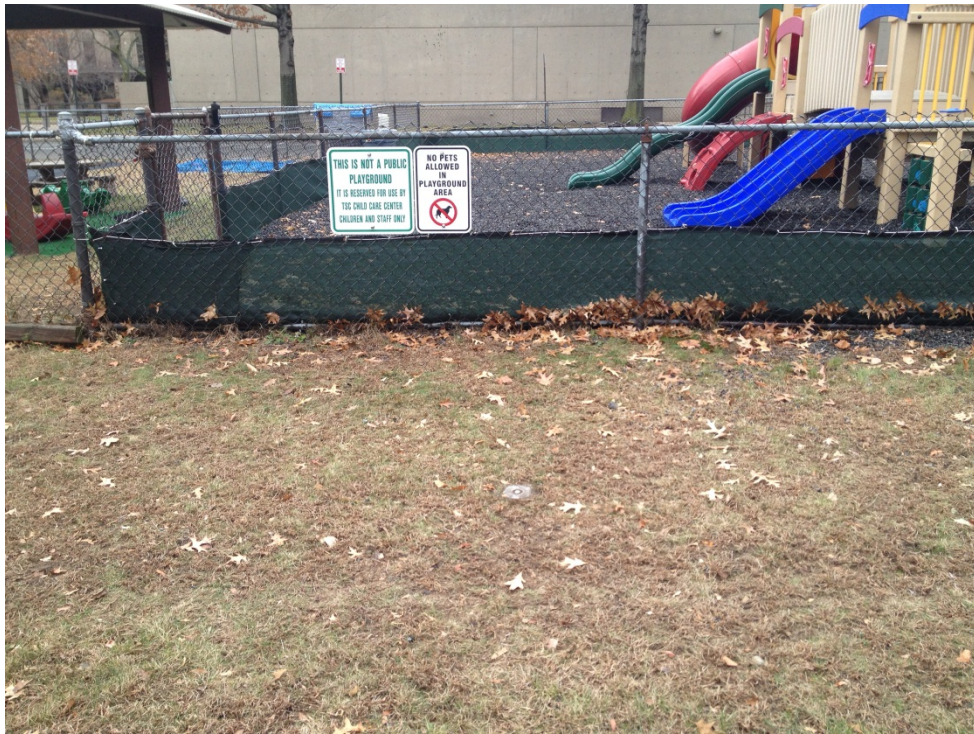
Exterior 5 - Monitoring well east of Playground

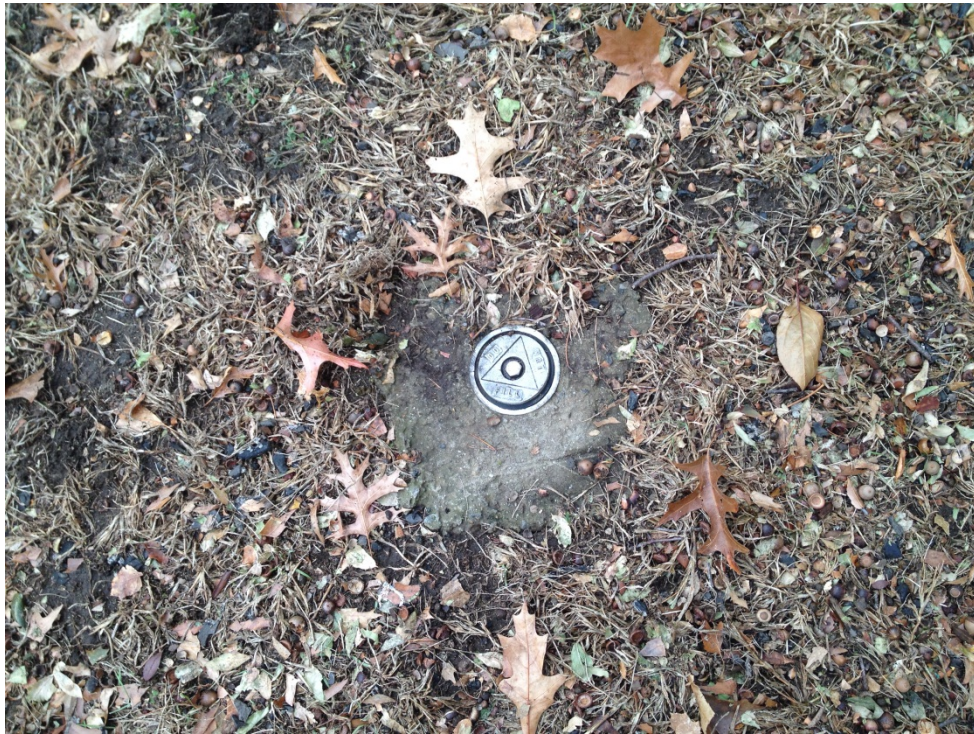
Exterior 6 – Close up additional monitoring well east of Playground

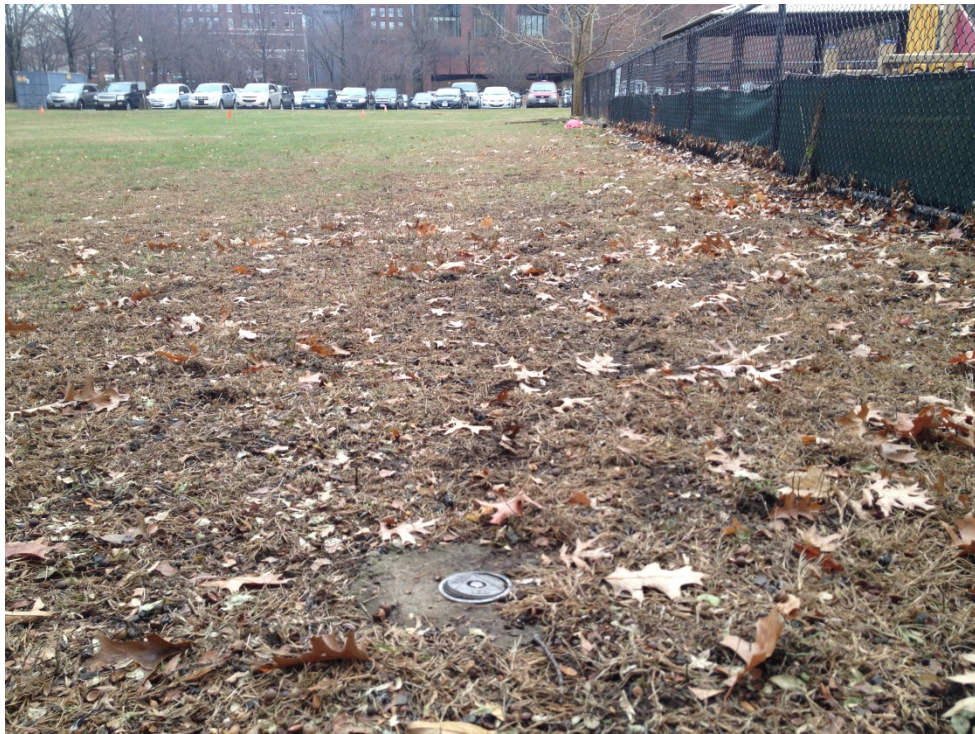
Exterior 7 - Additional monitoring well east of playground

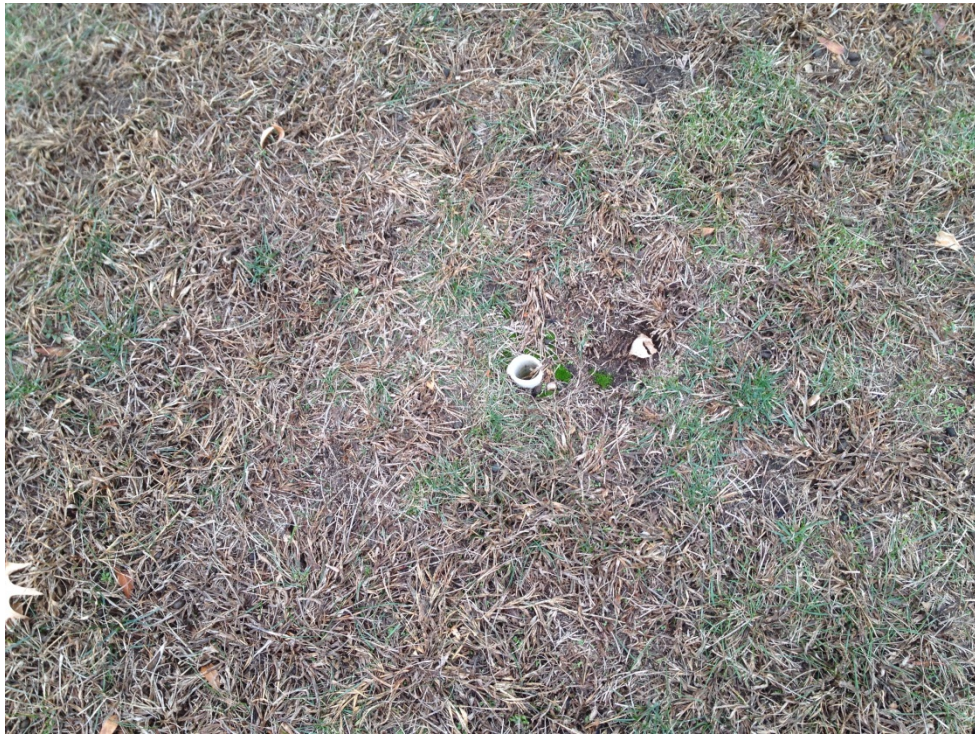
Exterior 8 – Close up damaged monitoring well south of playground

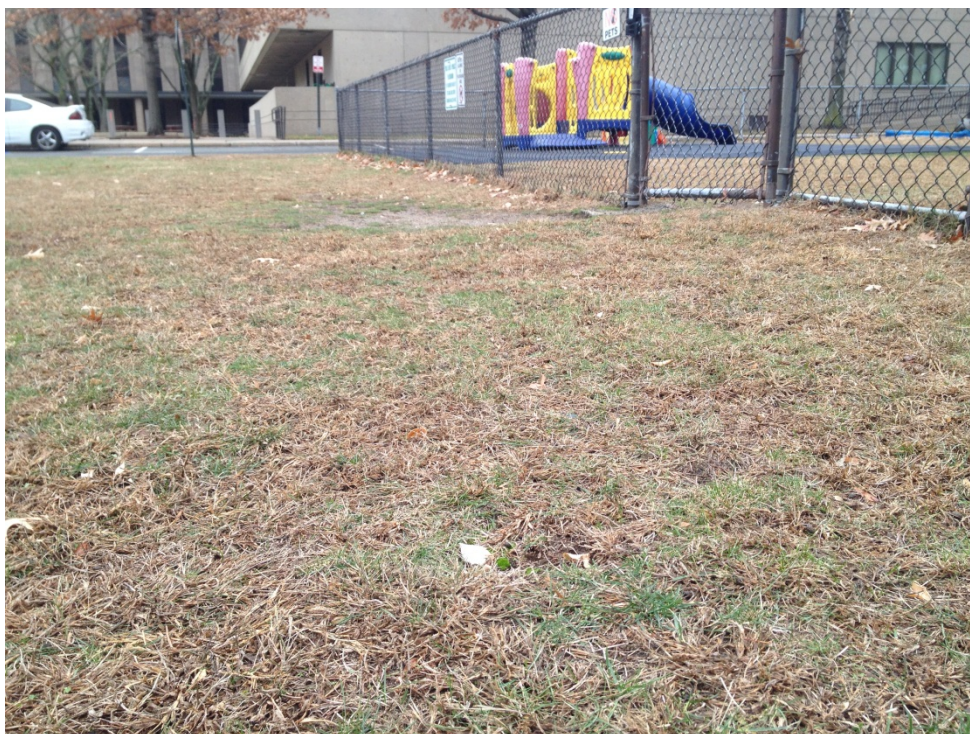
Exterior 9 - Damaged monitoring well south of playground

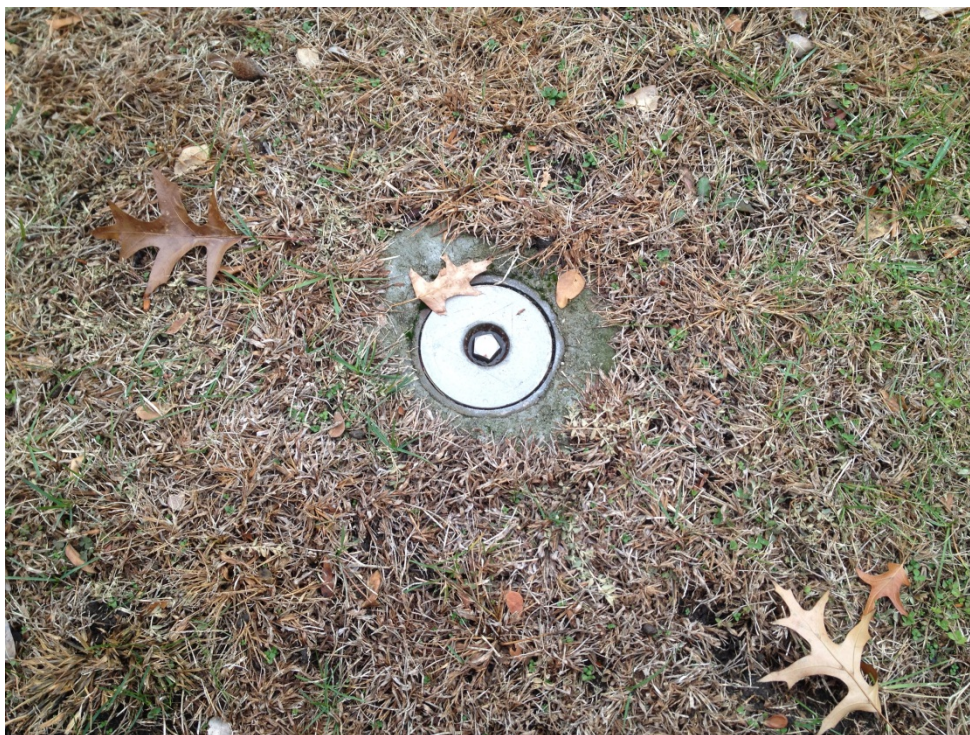
Exterior 10 - Close up monitoring well Volpe Courtyard

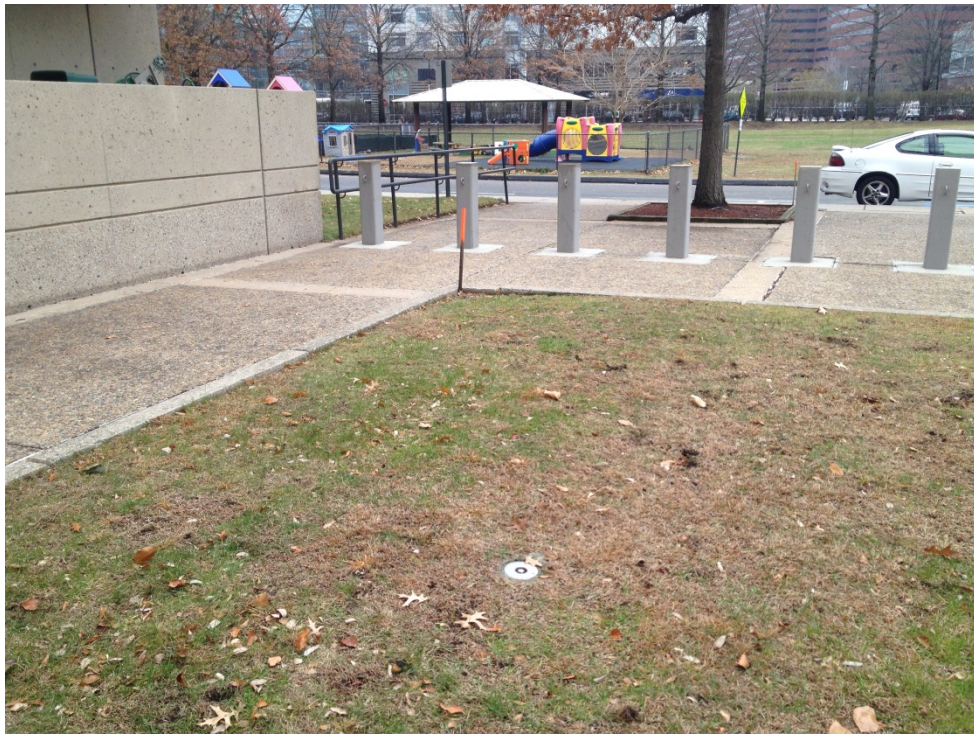
Exterior 11 - Monitoring well Volpe Courtyard

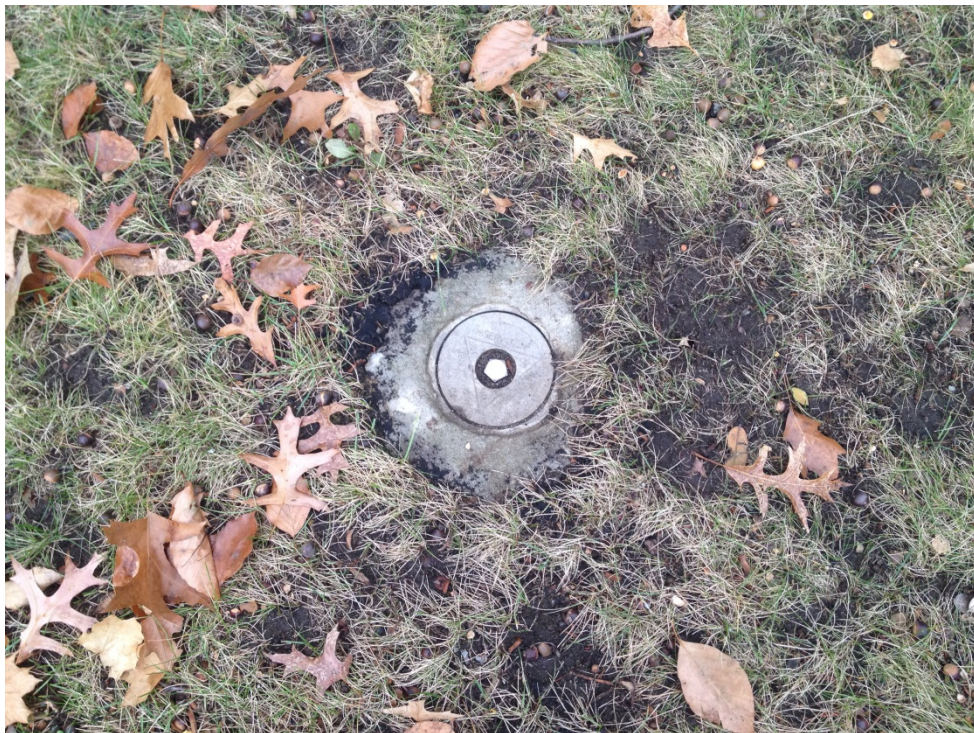
Exterior 12 - Close up monitoring well outside Daycare Facility

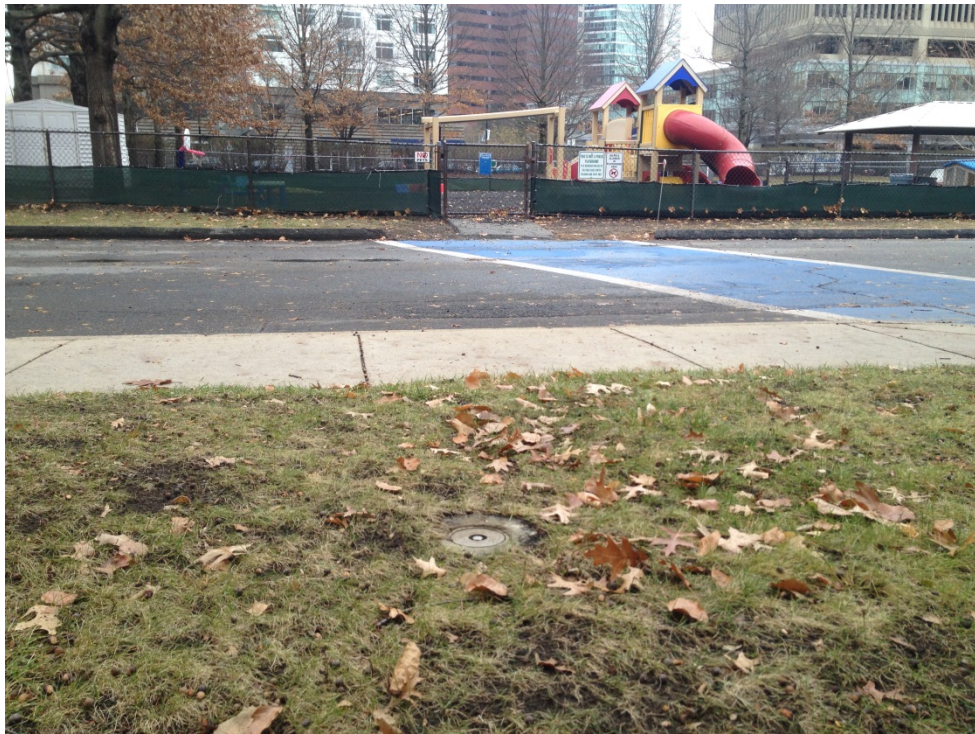
Exterior 13 - Monitoring well outside Daycare Facility

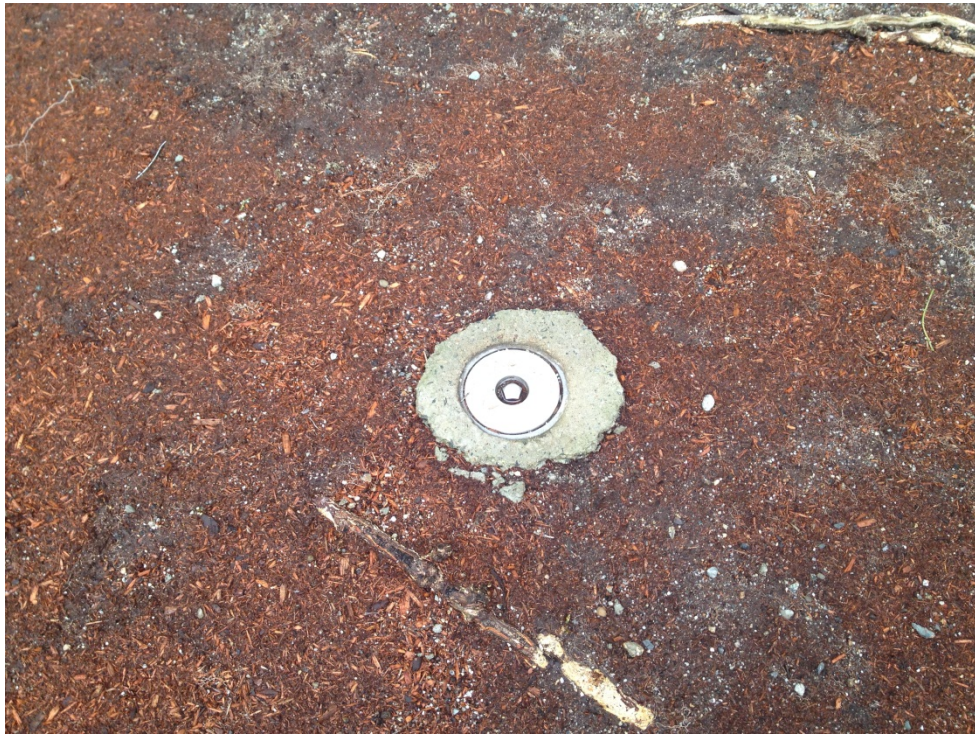
Exterior 14 - Close up monitoring well near Silo Building

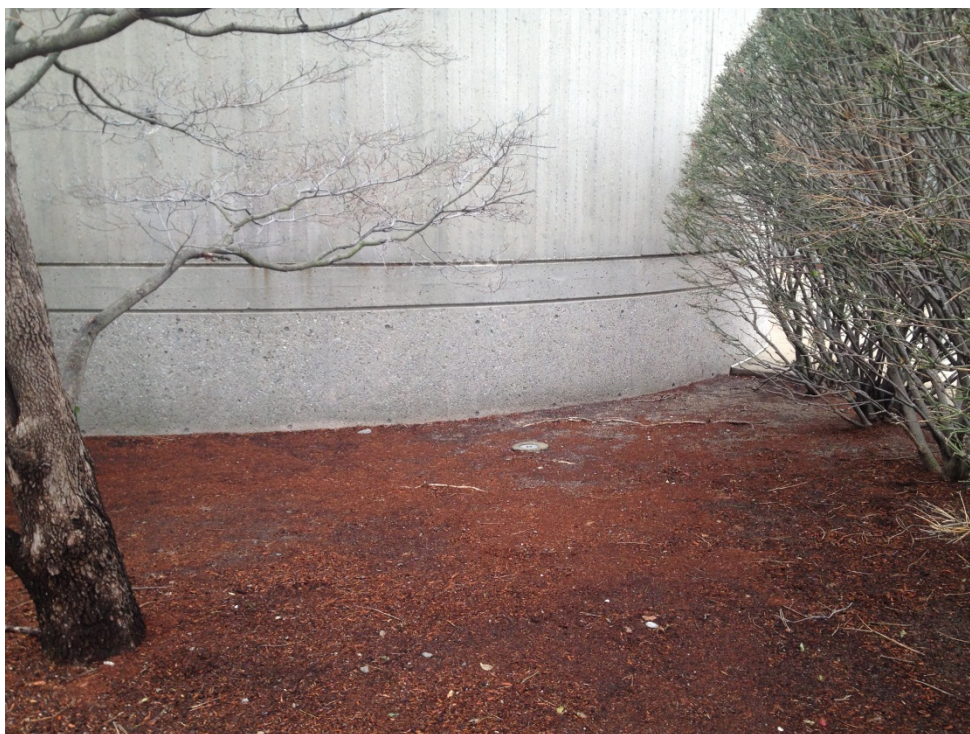
Exterior 15 - Monitoring well near Silo Building

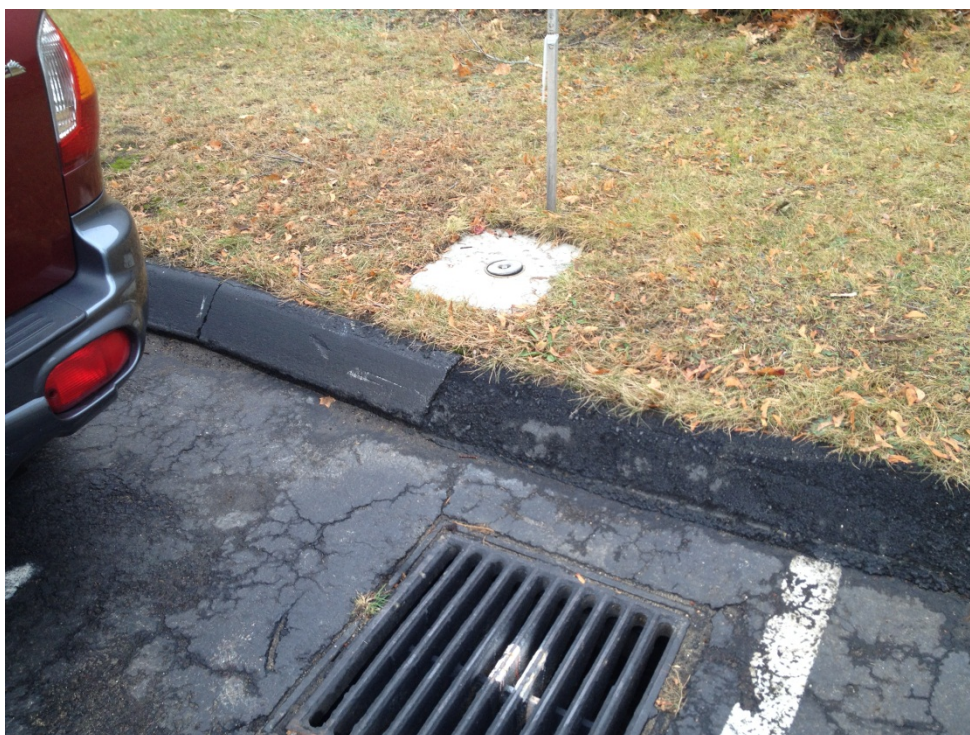
Exterior 16 - H&A monitoring well (1 of 4) for 225 Binney St. study

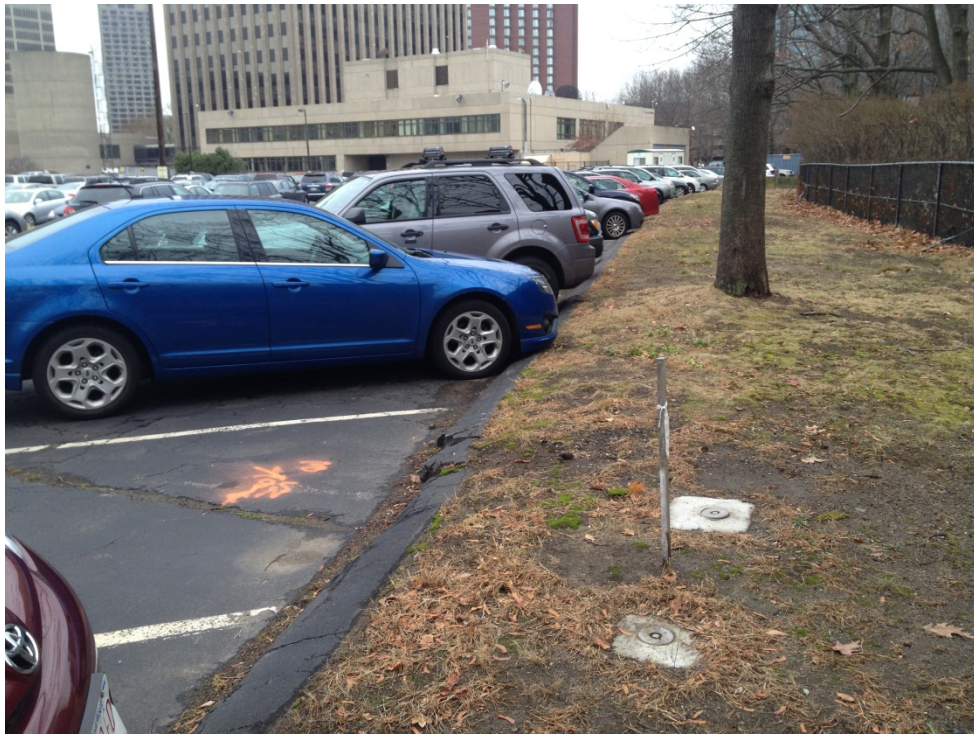
Exterior 17 – Close up of two H&A monitoring wells (2&3 of 4) for 225 Binney St. study

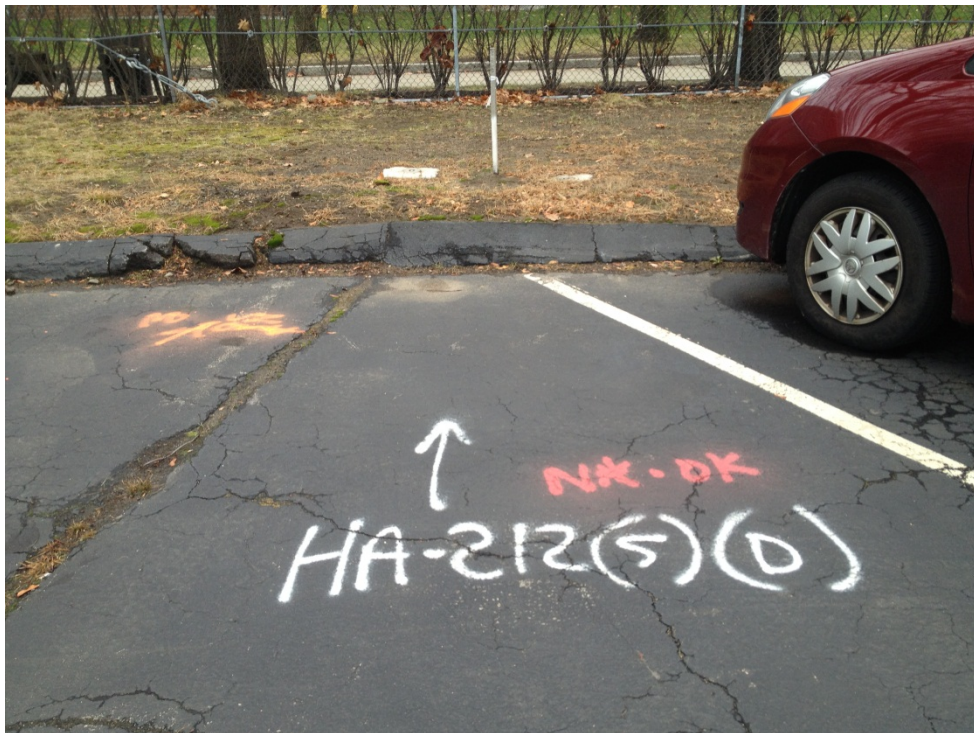
Exterior 18 - Two H&A monitoring wells (2&3 of 4) for 225 Binney St. study

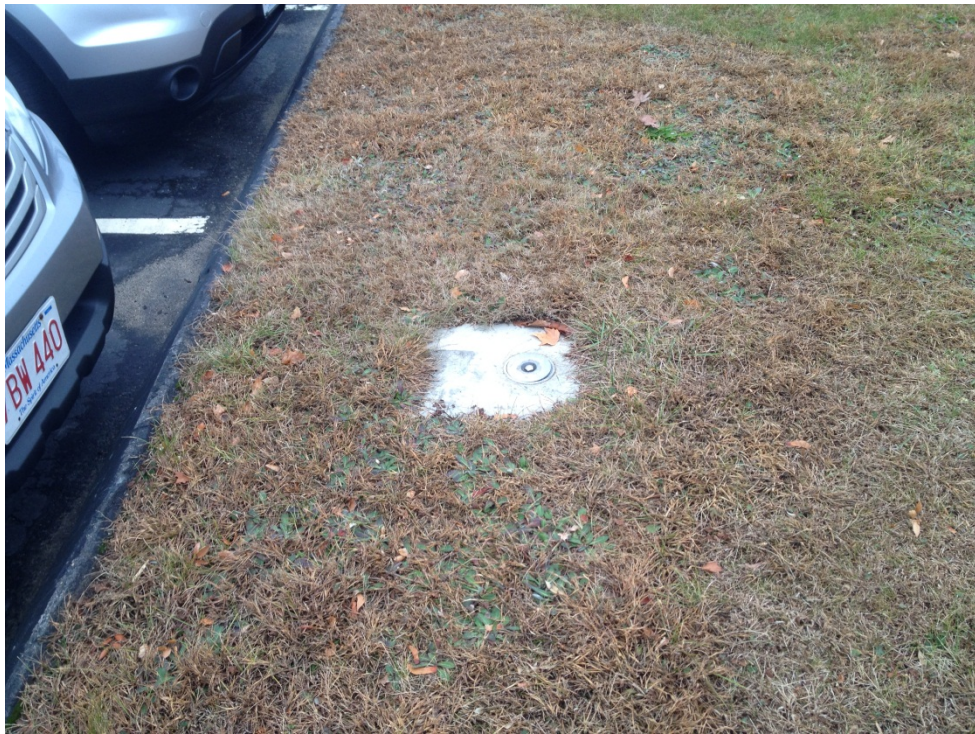
Exterior 19 - Close up H&A monitoring well (4 of 4) for 225 Binney St. study

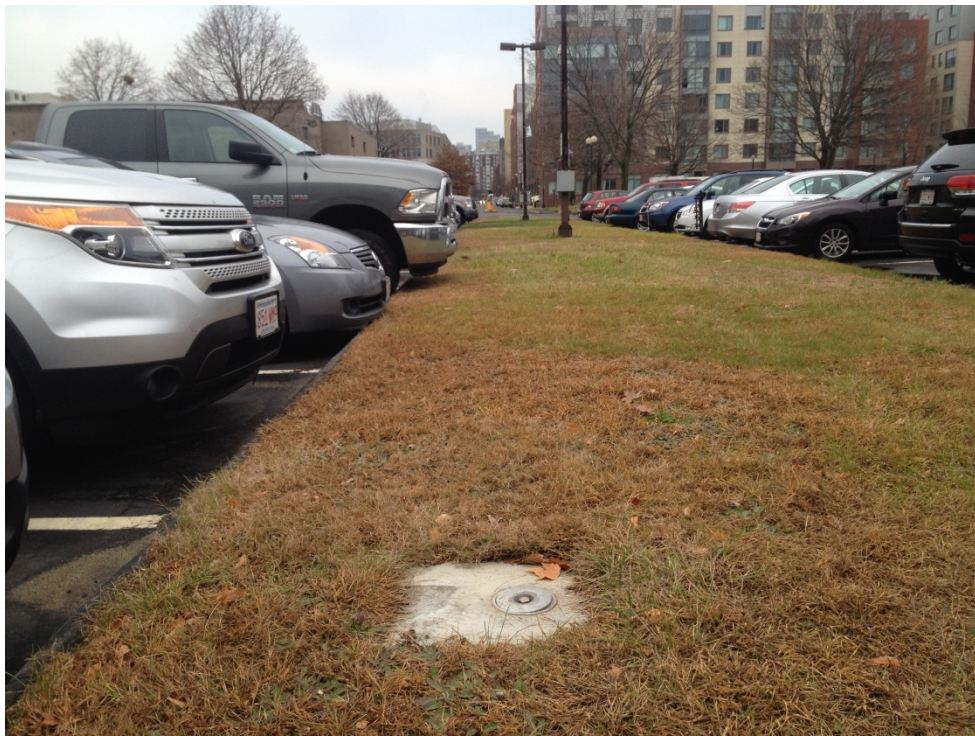
Exterior 20 - H&A monitoring well (4 of 4) for 225 Binney St. study
